# Cooke's Hollow

## Feasibility Study and Preliminary Design Report

Arlington, Massachusetts

August 2023

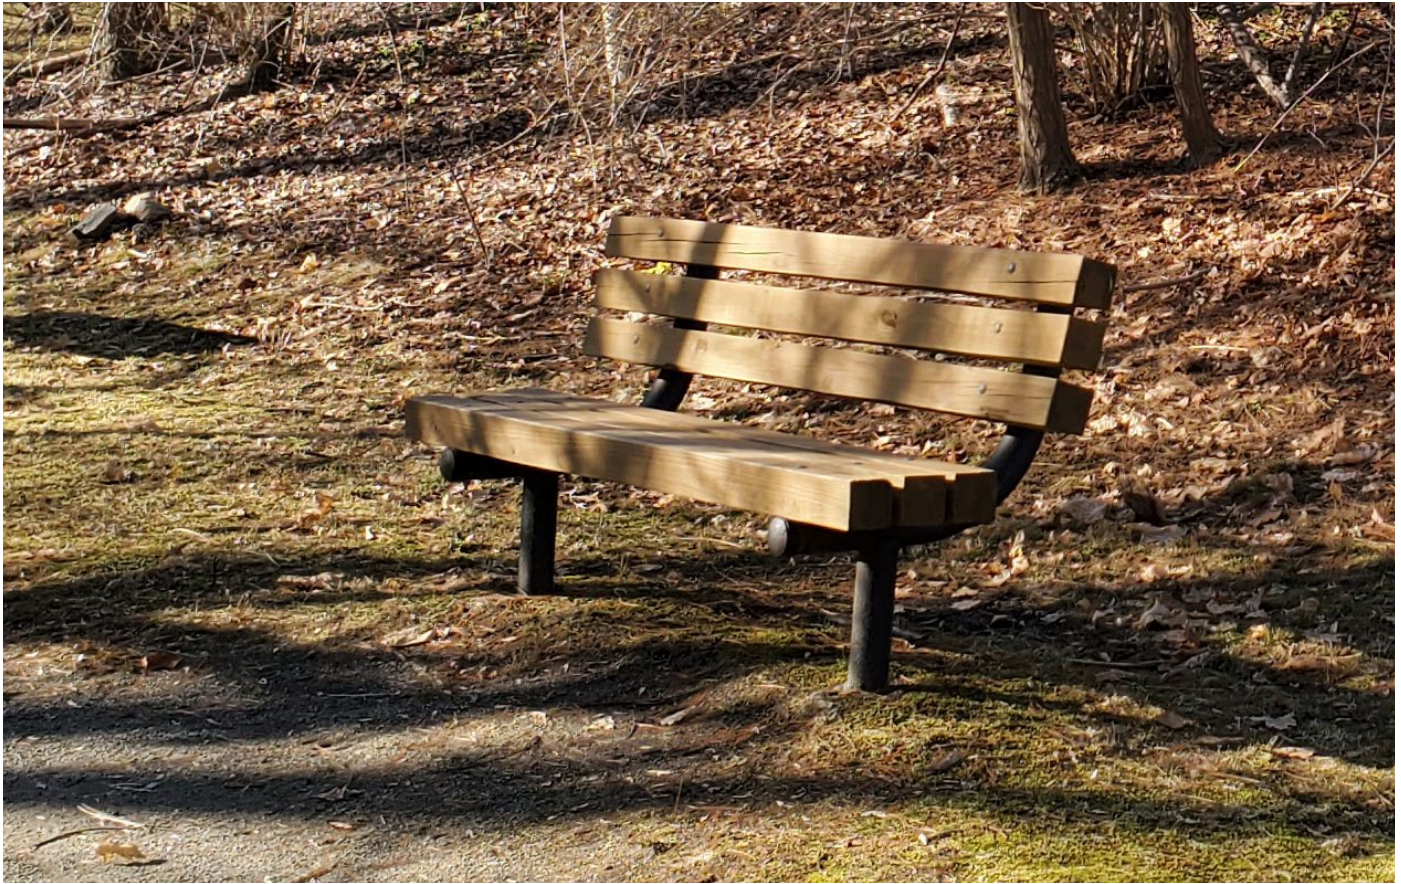
5 Wooden Path Bench

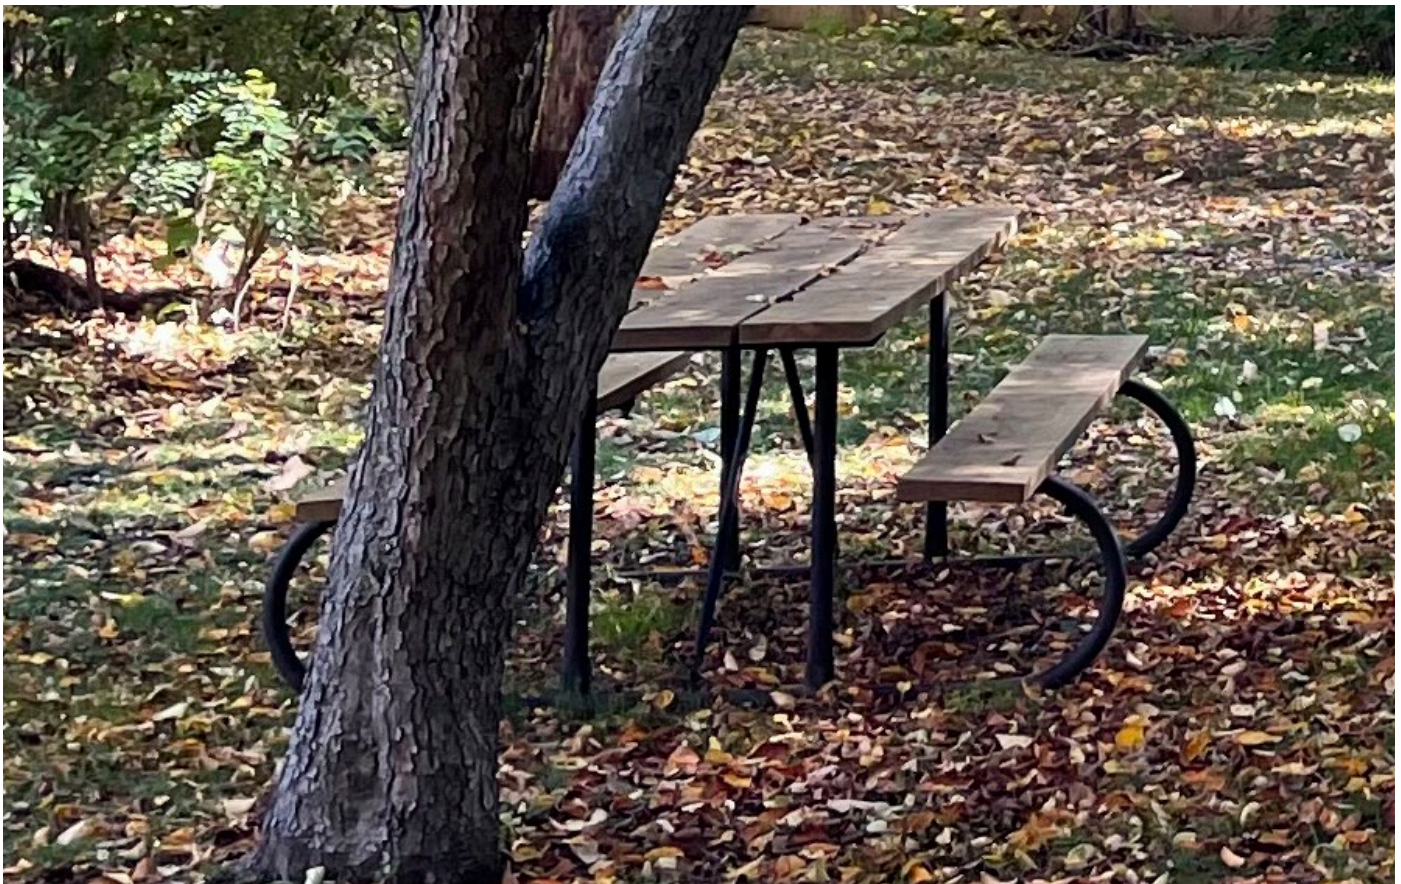
6 Picnic Table

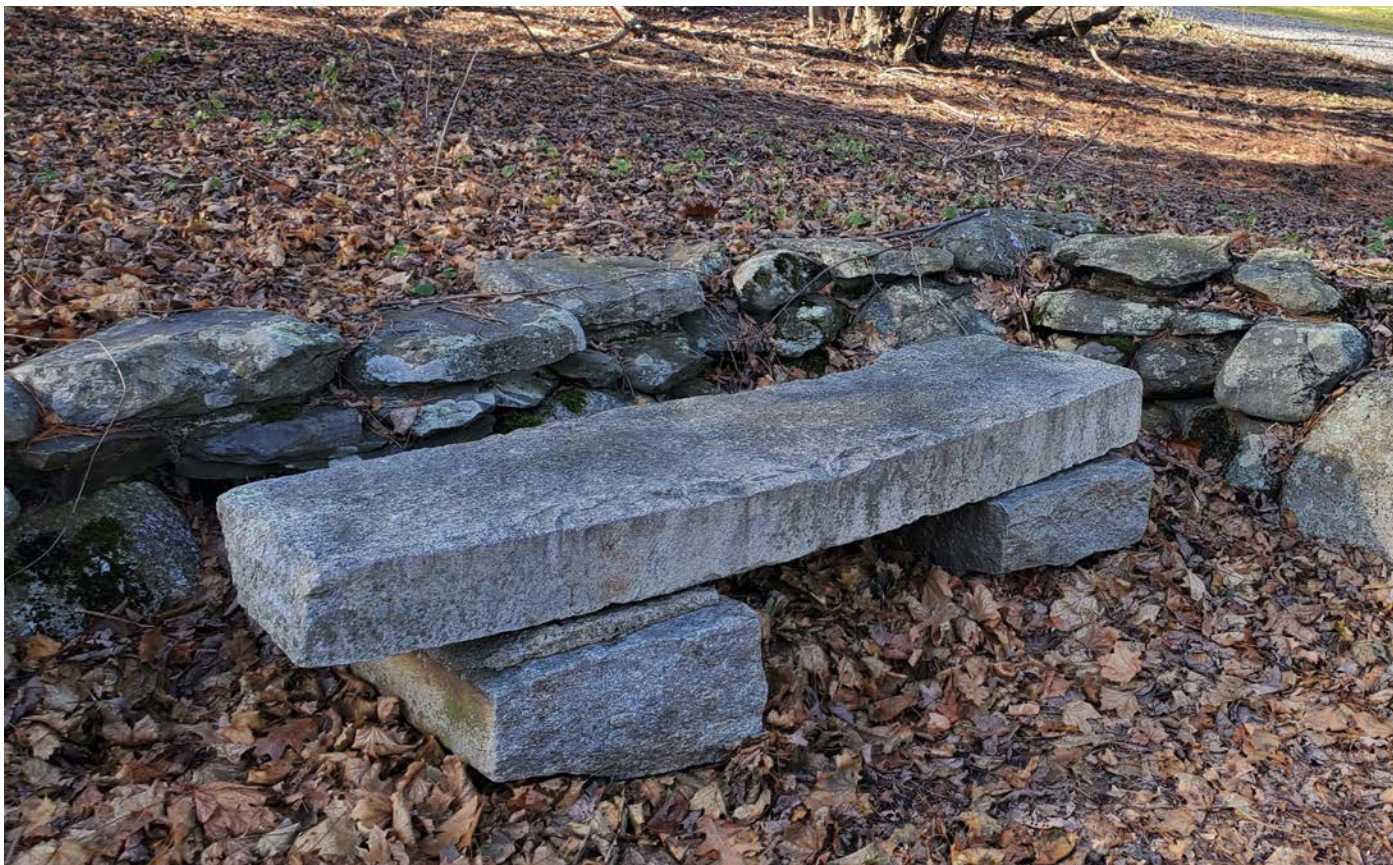
7 Granite Slab Bench Above Falls

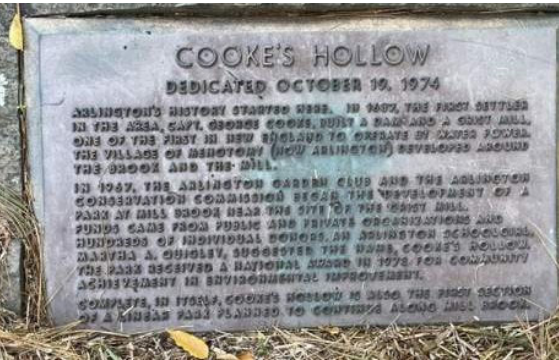
1 Memorial Plaque

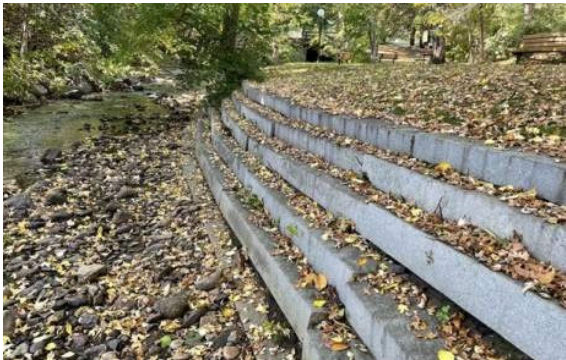
5 Granite Retaining Edge

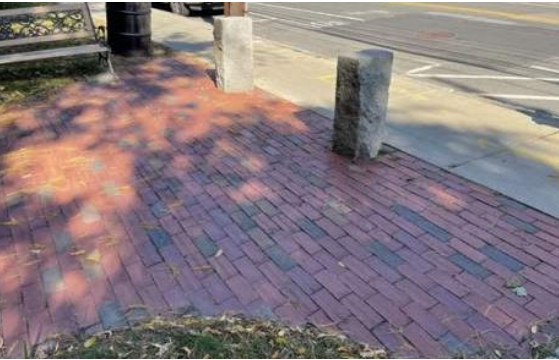
2 Granite Entry Piers & Paving

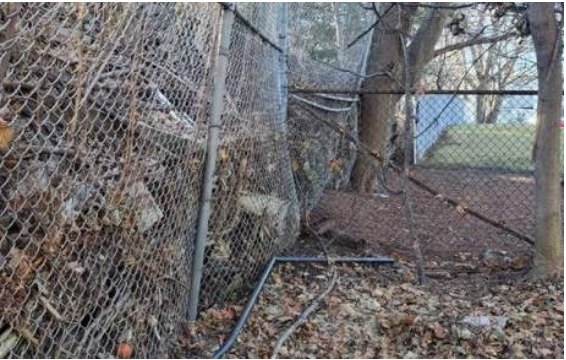
6 Chain link Fence with Debris

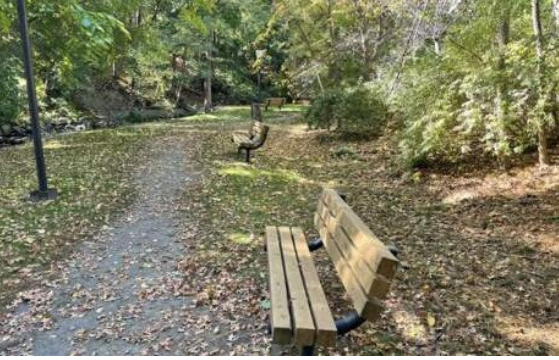
3 Stonedust Path & Benches

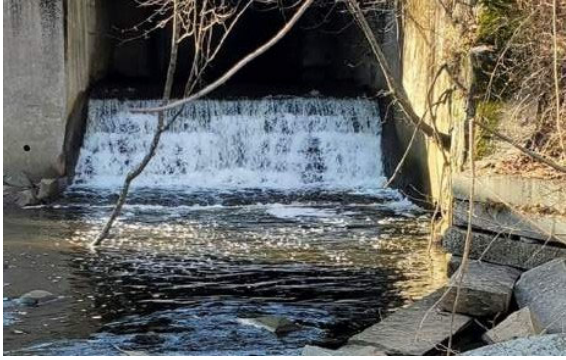
7 Waterfall

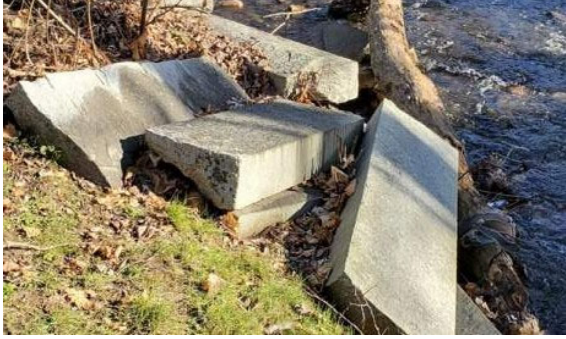
8 Stacked Granite Edge

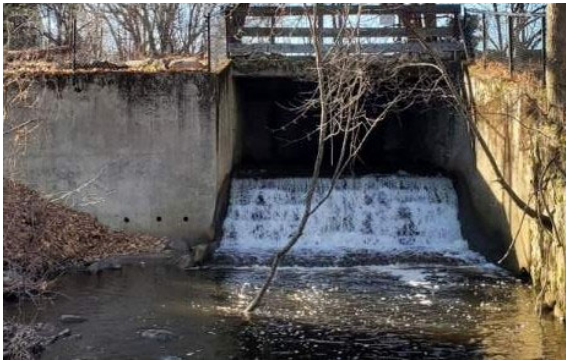
9 Manmade Dam & Wall

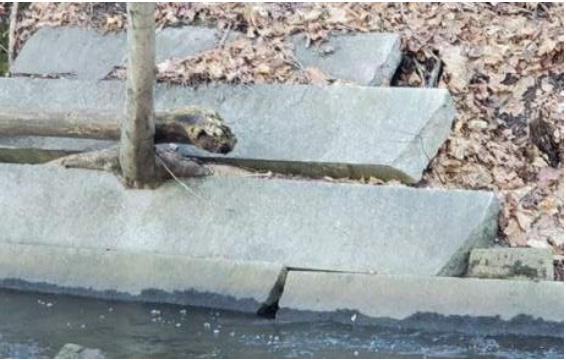
6 Armored Edge on Steep Slope

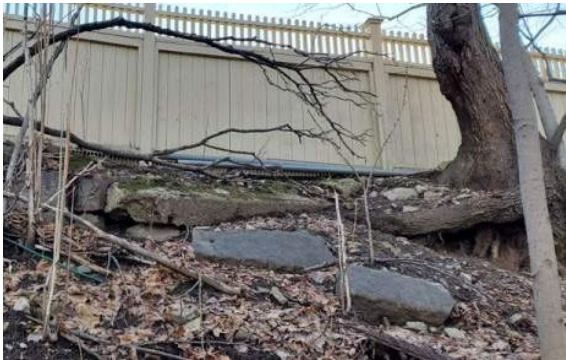
6 Privacy Fence

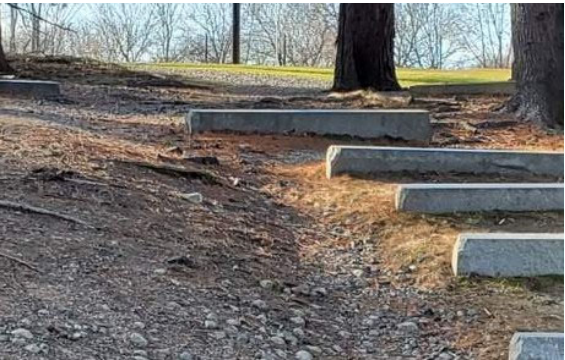
1 Erosion at Granite Treads

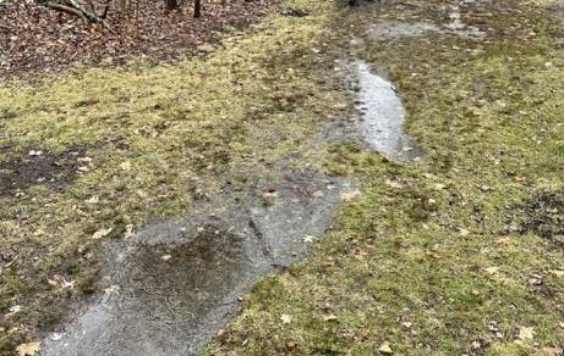
3 Standing Surface Water

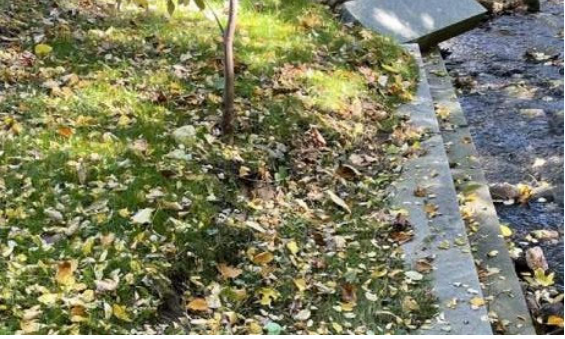
4 Erosion Behind Granite

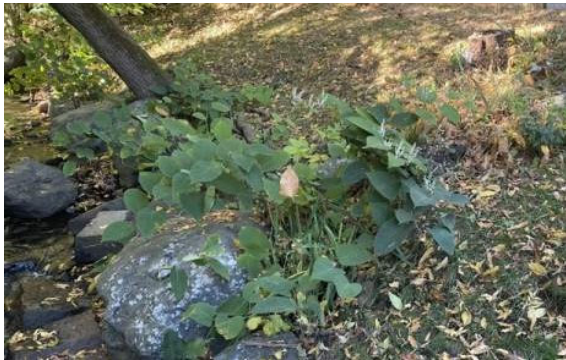
1 Japanese Knotweed

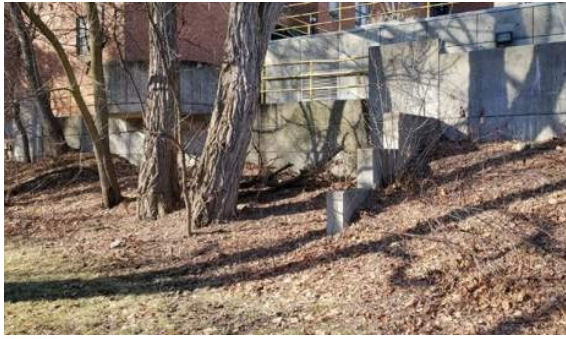
7. Dismay voiced over the potential removal of the large mature black locust trees. Preference voiced to replace them with large canopy flowering trees.

- i. Hatch explained they are classified as a public safety hazard by the arborist and discussed species including Northern Catalpa, Tulip Tree and Big Leaf Linden as possible replacements.

4 Black Locust Trunks

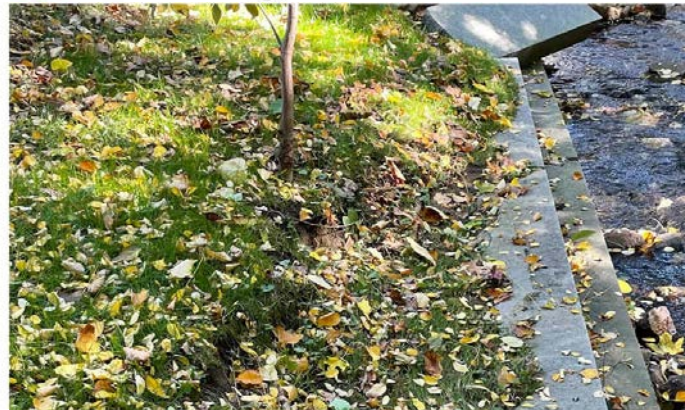
4 Erosion and Soil Settlement along Mill Brook

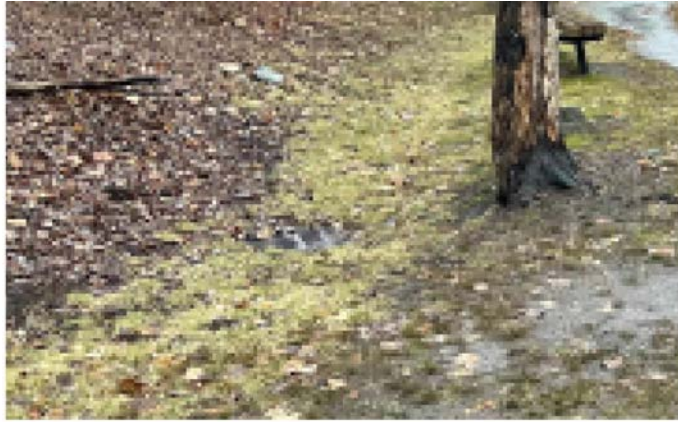
1 Swale Between Path and Parking Lot Edge

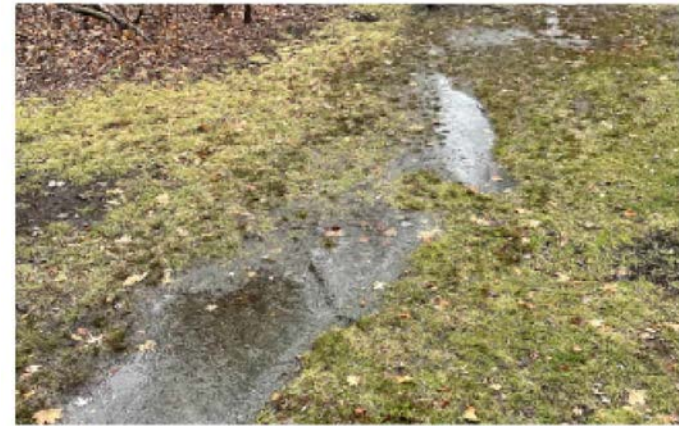
3 Ponding and Surface Runoff Near Picnic Table

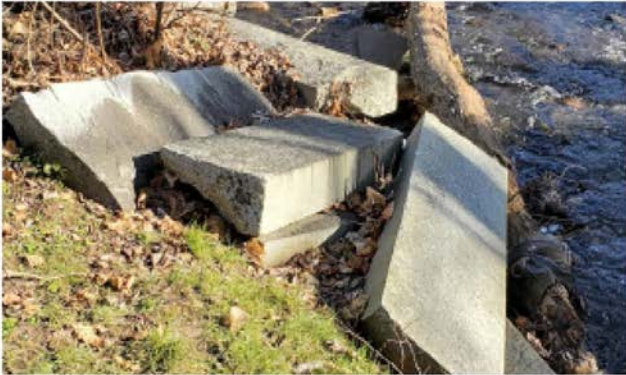
8 Stacked Granite Edge In Need of Repair

8 Stacked Granite Curb
